Special Report 76-11

OBSERVATIONS
ALONG THE PIPELINE HAUL ROAD
BETWEEN
LIVENGOOD AND THE YUKON RIVER

R. Berg and N. Smith

October 1976

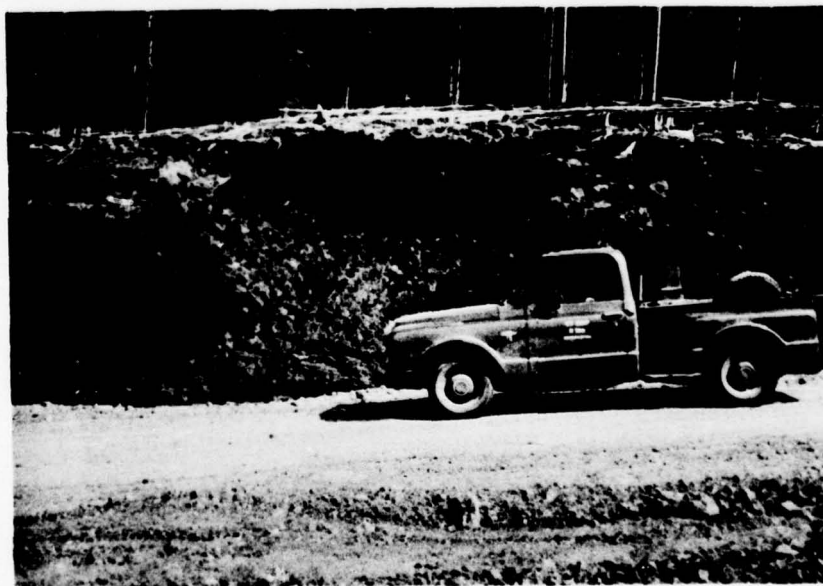
This cut slope faces southwest and the top of the slope is 8-10 ft (2.4-3.0 m) above the roadway surface. The upper portion of a massive ice mass can be observed 3-4 ft (0.9-1.2 m) below the top of the slope in Figures 9 and 10. These two photographs, taken on 26 June 1970 show that the mineral soil overlying the ice is relatively dry. Figures 11 and 12 show the grass growth from June till August 1970. Figures 13-15 show the slope on 27 May 1971. A small amount of litter from the previous years' growth of grasses is visible and the organic mat is hanging over the thawed soil; however, it has torn in some places. Figures 16 and 17, taken nearly two years later, show the remnants of a substantial growth of grass. The slope does not have a "neat" appearance, however. Figures 18 and 19 show the slope on 27 September 1974. A few small trees are visible at this time and a substantial growth of grass has occurred during the summer. Figures 20 and 21 show the slope on 14 September 1975. The trees had grown considerably since the previous year. Due to their shading effect, thus permitting less thaw and removal of subsurface moisture, the trees and grasses have assisted in making this a relatively stable slope.

9. Thawing backslope, Mile 4.5 Rt, 26 June 1970.

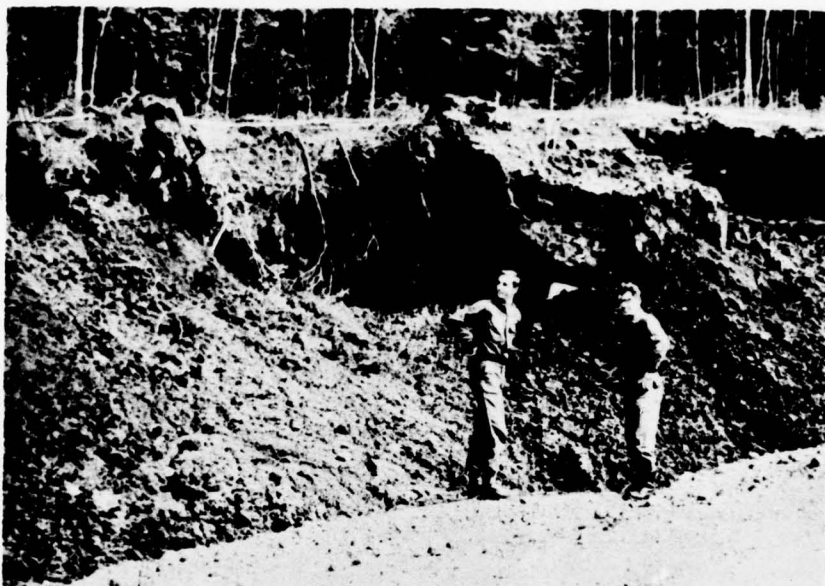
10. Organic mat overhanging part of thawing backslope,
26 June 1970.

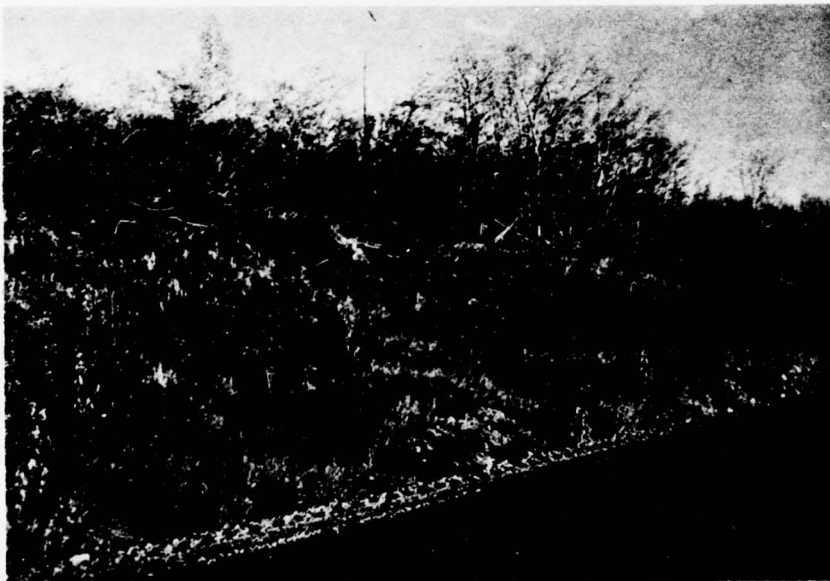
restrain the mineral soil as it fell from the receding ice. On 28 May 1971 the berm was easily observed (Fig. 25 and 26). Most of the slope appeared relatively stable but a small part continued to degrade rapidly (Fig. 26). Figure 27, taken on 27 September 1974, shows the same area as Figure 24 and represents a nearly stable condition on the shallow slope.

27. Stabilized shallow backslope, Mile 9.85 Rt,
27 Sept 1974.

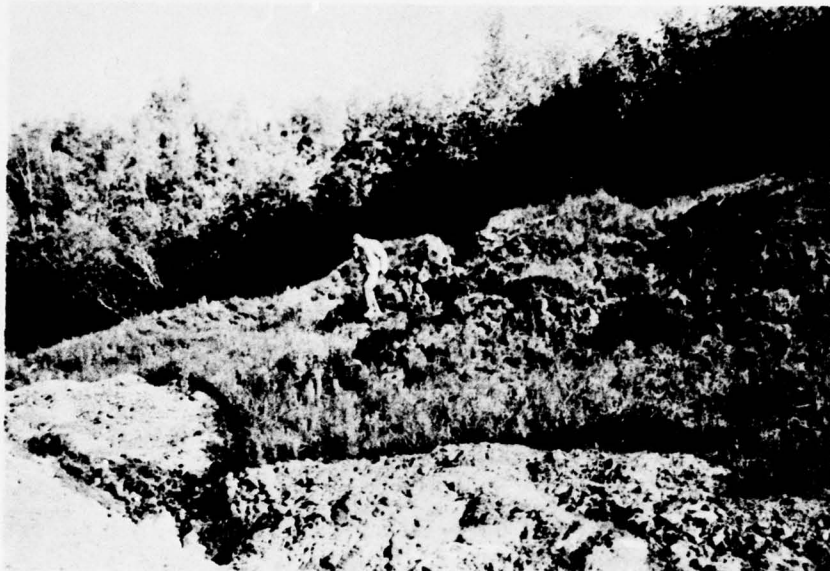
The second slope at this site developed stability problems during the second thaw season. It can be seen at the extreme left in Figure 25. It is much higher but the ice-rich soil was not exposed during construction. The photographs taken on 17 August 1971, Figures 28 and 29, show the massive movement and the disruption of the relatively heavy grass cover caused by subsurface thawing. The slope looked quite stable in September 1974 when last photographed. The grass cover had rehealed and some small trees had started to grow (Fig. 30).

28. Most unstable portion of deep cut, Mile 9.85 Rt, 17 August 1971.

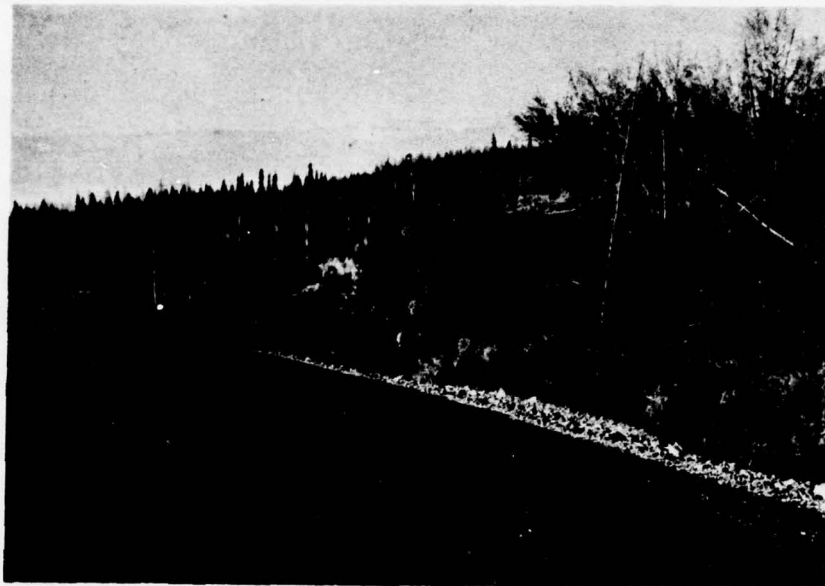
30. Overall view of stabilized deep cut, Mile 9.85 Rt,
27 September 1974.

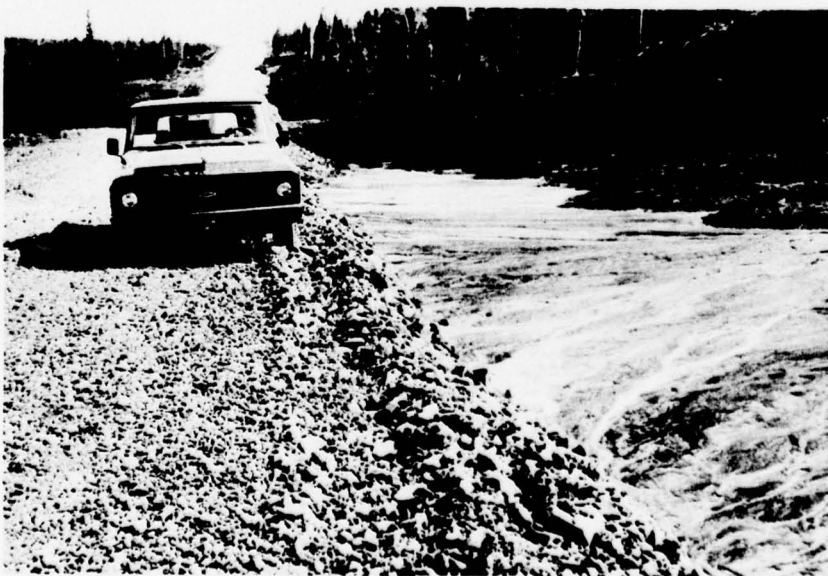
33. Backslope erosion into parallel ditch,
Mile 19.6 Lf, 26 June 1970.

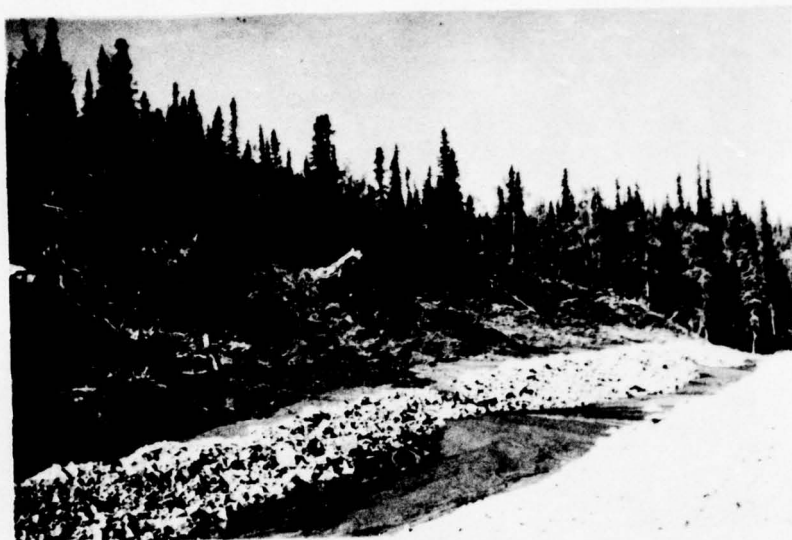
34. Seeded backslope and broken rock revetment,
Mile 19.6 Lf, 11 August 1970.

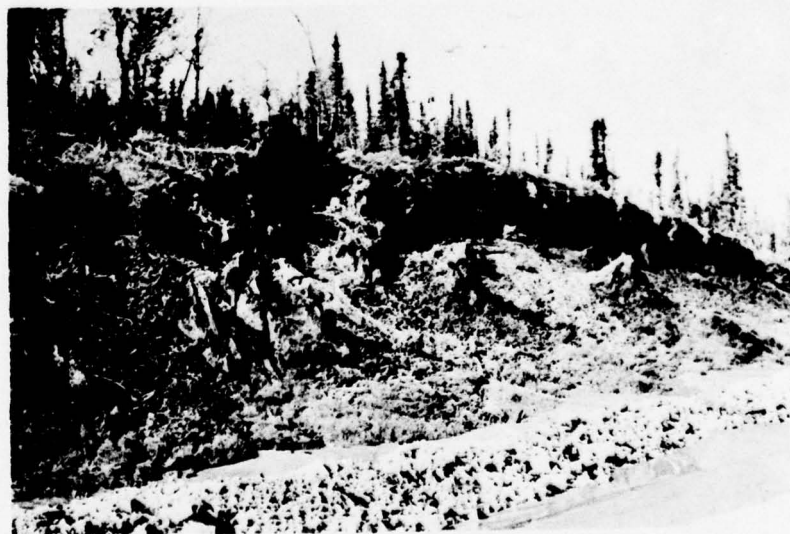
35. Thawing slope receding into limit of clearing,
Mile 19.6 Lf, 11 August 1970.

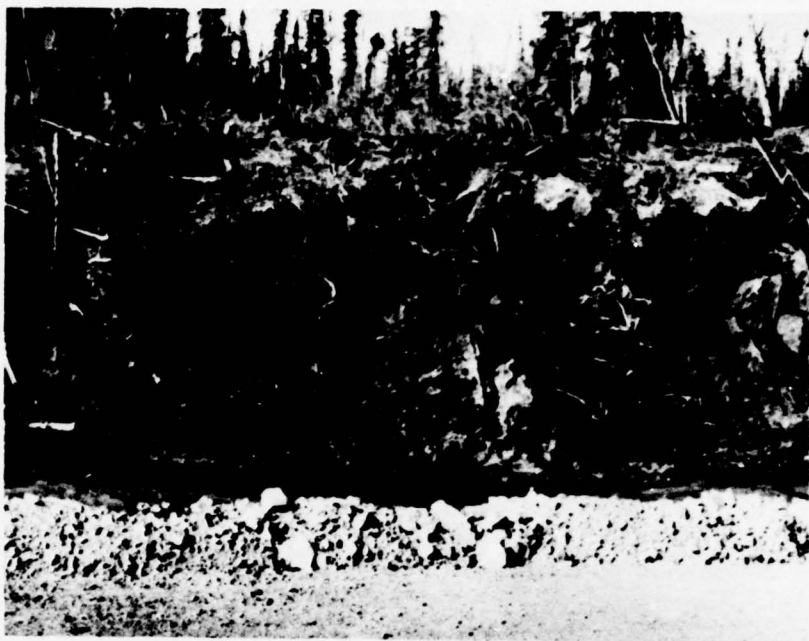
38. Close-up of overhanging vegetative mat, Mile 19.6 Lf,
28 May 1971.

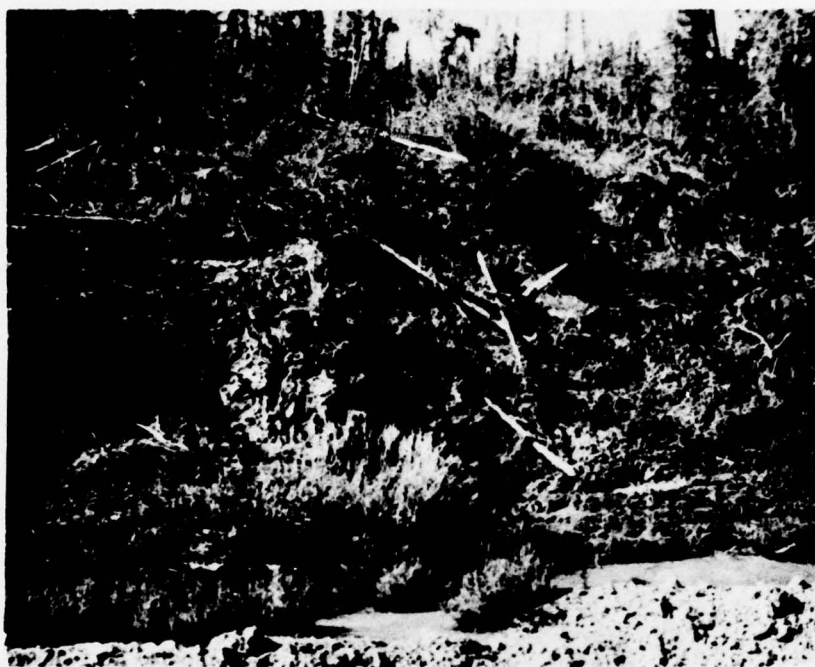
40. Close-up of grasses in ditch and continued thawing of backslope, Mile 19.6 Lf, 17 August 1971.

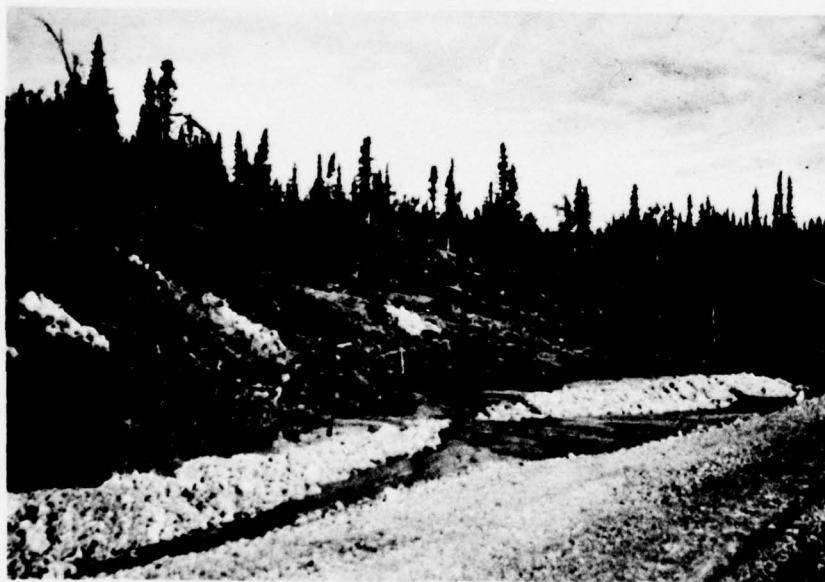
41. Overall view of slope showing toppling spruce trees, Mile 19.6 Lf, 23 June 1972.

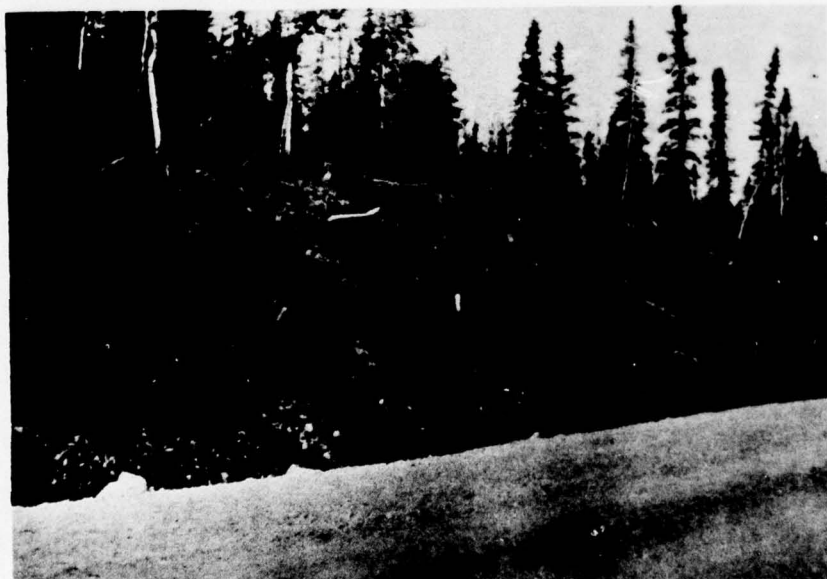
(Fig. 46). Figure 47 illustrates the organic mat hanging over the receding slope on 28 May 1971. On 17 August 1971 portions of the slope looked fairly stable (Fig. 48), while on other parts of the slope the organic mat had torn and vegetation was sparse (Fig. 49). The slope was in a similar condition in June 1972 (Fig. 50). During the summer of 1973 a major portion of this backslope was re-excavated to expose the ice-rich permafrost. An experiment was initiated to determine the effects of spraying foamed-in-place insulation on such backslopes as an alternative method for achieving slope stability. Polyurethane insulation was sprayed onto the newly exposed slope and the cleared area above the slope. Figure 51 is a photograph of the slope on 27 September 1974 and Figure 52 is a close-up of the insulation. Figures 53 and 54 show the slope on 14 September 1975. Lush grass is evident above and below the insulating layer and at a few breaks in the insulation. The surface of the insulation had degraded noticeably, but the slope did not appear to be melting and receding. It will be very interesting to observe the behavior of this slope for the next few years. Quite possibly this slope would have healed to the extent of those previously discussed if the insulation had not been applied.

47. Sloughing slope overtopping broken rock revetment, Mile 19.9 Lf, 28 May 1971.

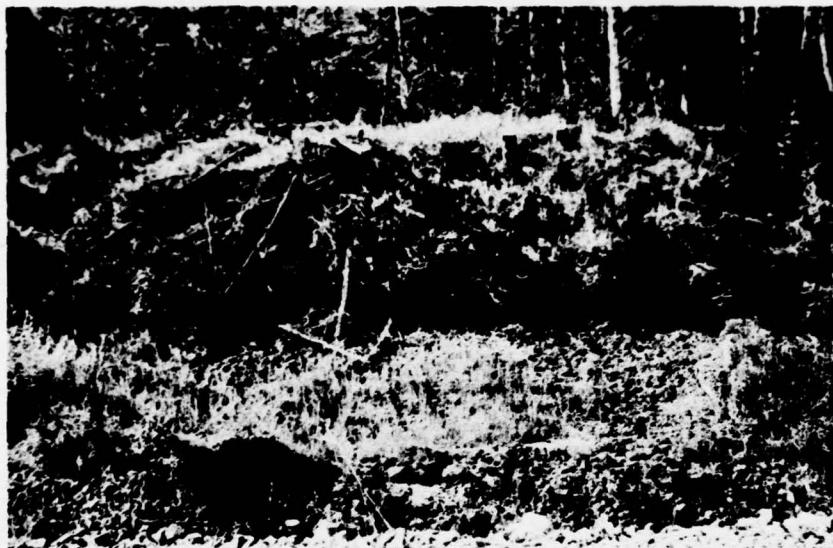
48. Part of backslope appearing fairly stable, Mile 19.9 Lf, 17 August 1971.

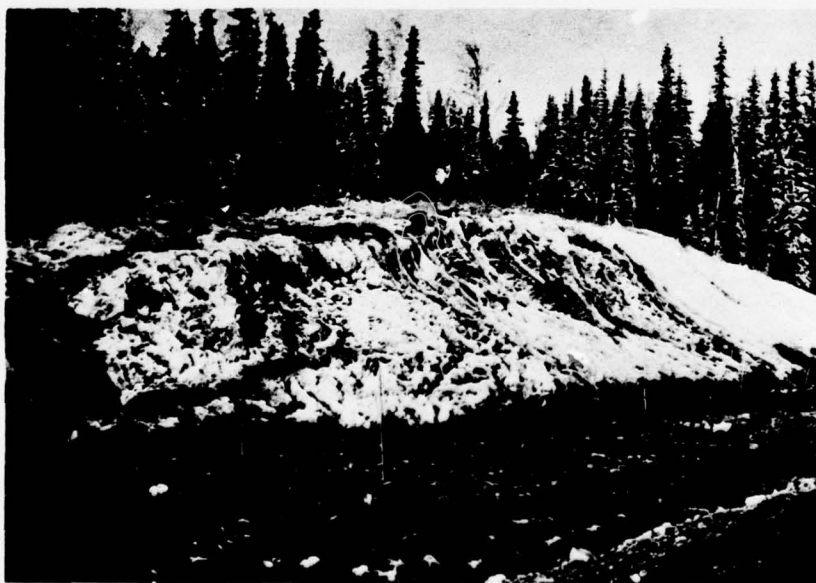
51. Insulation covering backslope, Mile 19.9 Lf, 27 September 1974.

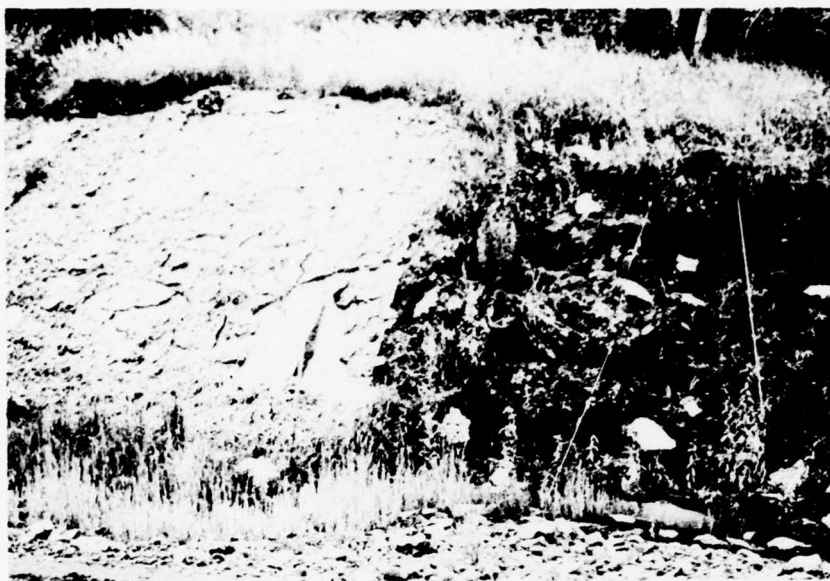
54. Insulated and uninsulated portions of backslope,
Mile 19.9 Lf, 14 September 1975.

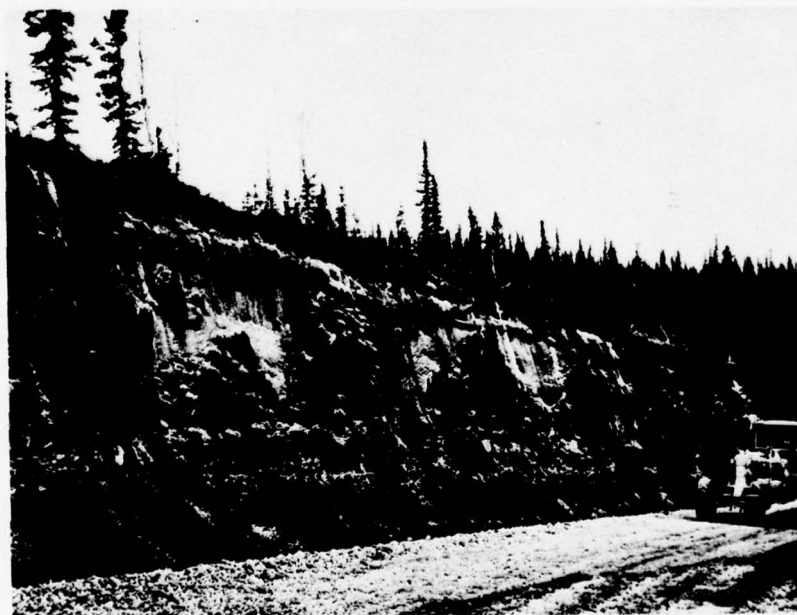
55. Frozen nearly-vertical backslope with large ice masses,
Mile 20.25 Lf, 23 April 1970.

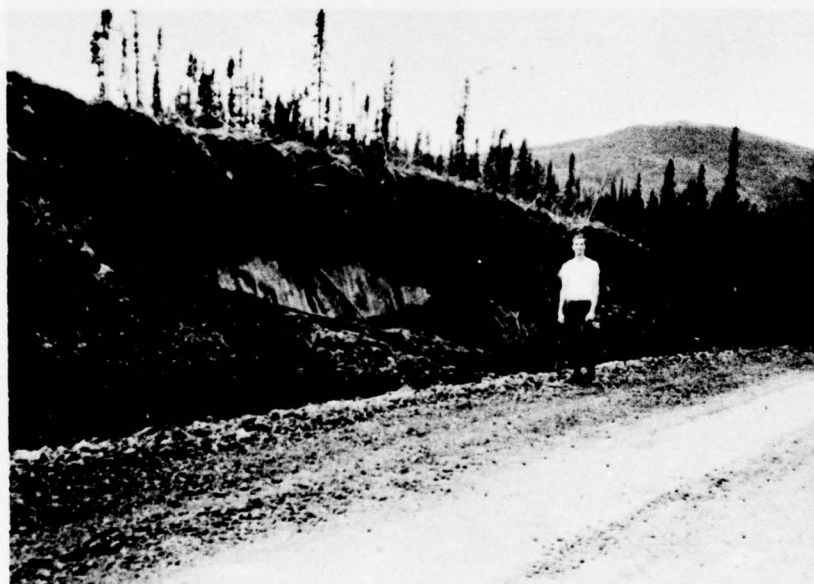
On the left side of the road, the top of the cut is about 10 ft (3.0 m) above the road surface. Massive ice was observed on 23 April 1970 (Fig. 68) extending from about 5 ft (1.5 m) below the top of the cut down to the drainage ditch. This large mass of ice was exposed over most of the length of the cut, probably 100 ft (30 m) or more. Because a relatively small volume of mineral soil had overlain the massive ice, much of the ice was still visible on 26 June 1970 (Fig. 69). Figures 70-74 illustrate that a portion of the slope continued to degrade through the 1972 summer. However, by 27 September 1974 most of the slope was covered by a dense cover of grasses (Fig. 75). A few small trees were also observed at that time. This site was not photographed in September 1975; however, future observations will determine whether the recession of a portion of the slope continues. The lack of tree growth on the slope is undoubtedly due to the absence of birch and willow trees in the area. As seen in the photographs, spruce is the predominant tree type, and it is not a rapid self-propagating species.

69. Massive ice still visible, Mile 22.9 Lf, 26 June 1970.

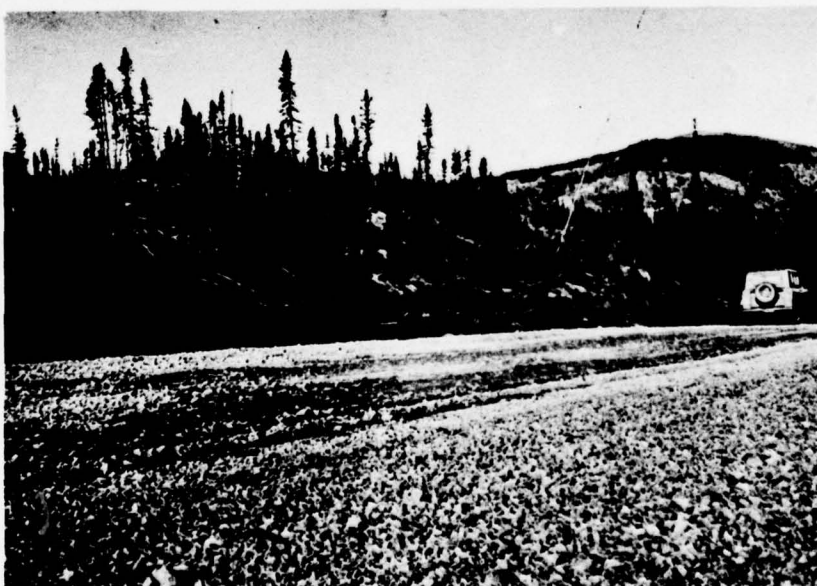
71. Grass not started on portion of backslope, Mile 22.9 Lf, September 1970.

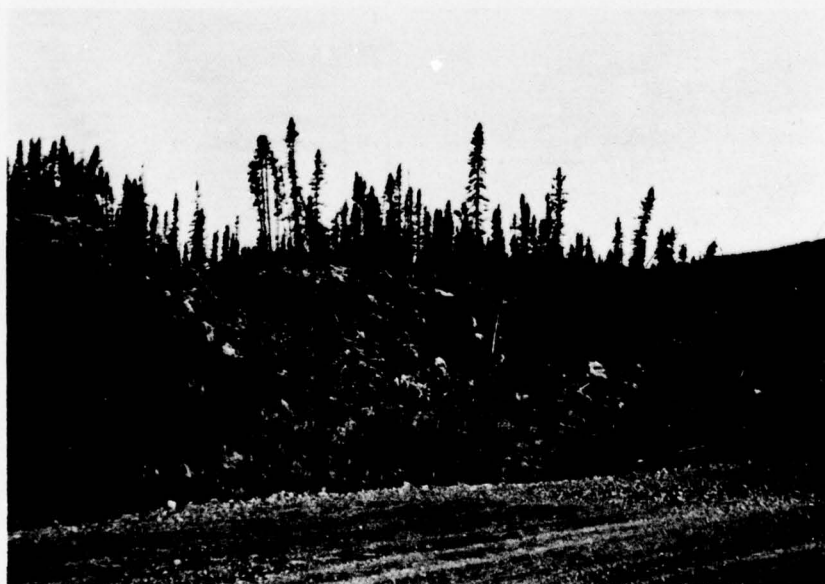
73. Continued instability of backslope, Mile 22.9 Lf, 23 June 1972.

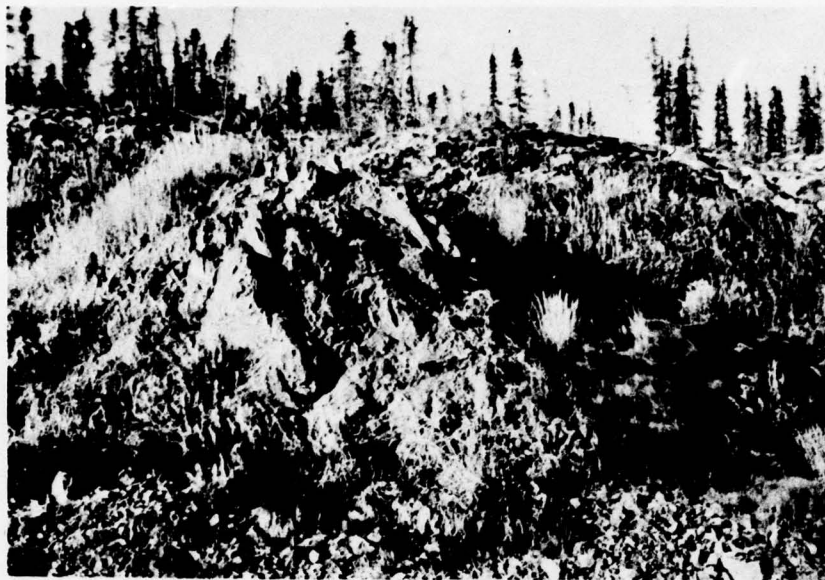
88. Close-up of vegetation and relatively dry mass of soil not supporting grass, Mile 23.2 Lf, 27 September 1974.

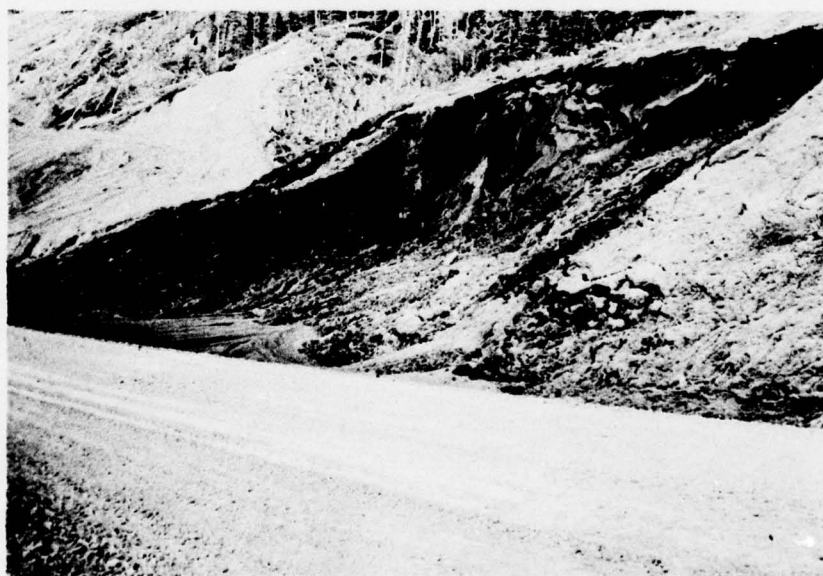
91. Close-up of start of sloughing, Mile 33.1 Rt, 26 June 1970.

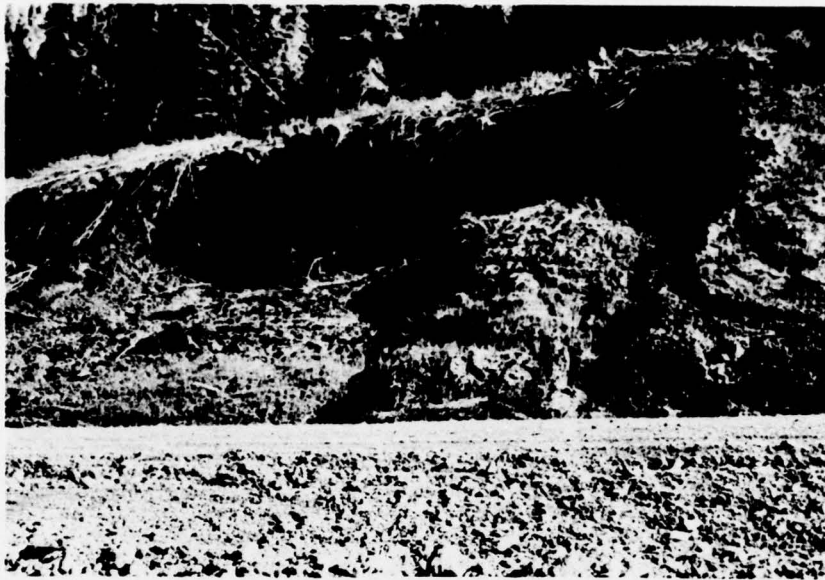
94. Receding slope, Mile 33.1 Rt, September 1970.

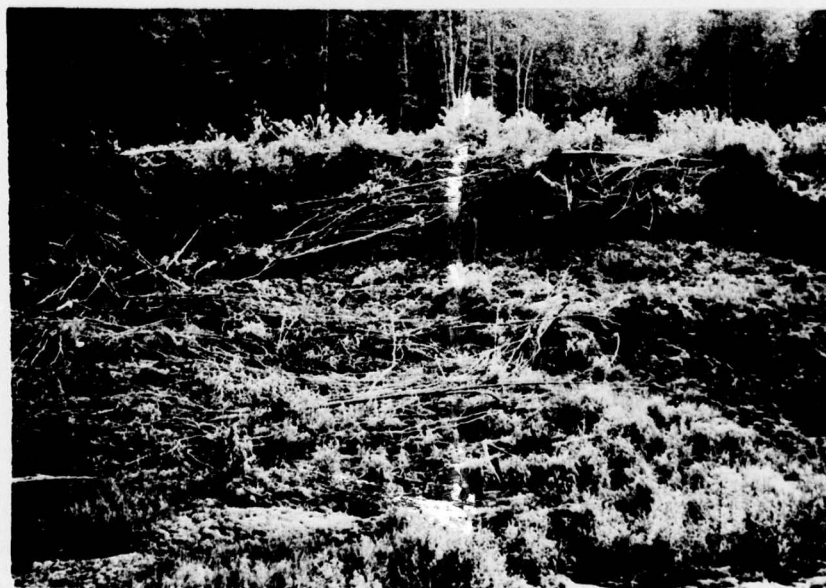
99. Fallen trees and overhanging mat, Mile 33.1 Rt, 23 June 1972.

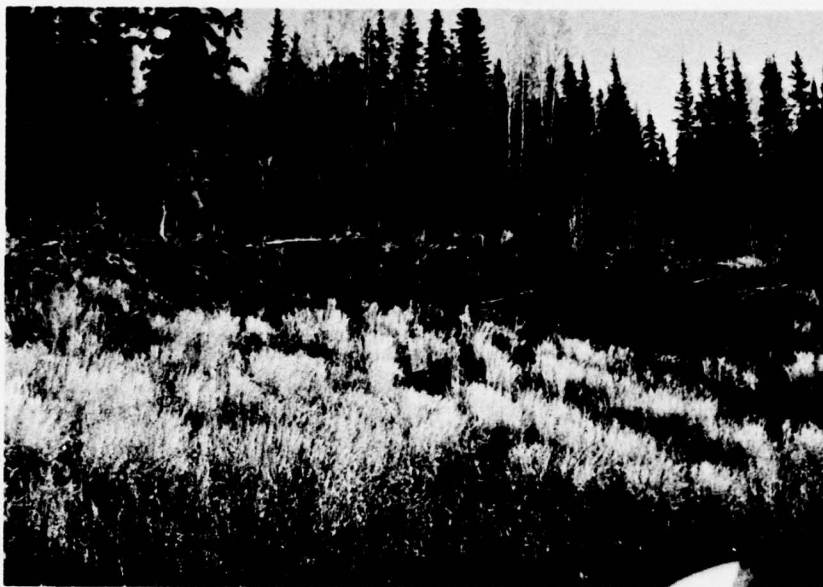
102. Relatively stable backslope, Mile 33.1 Rt, 27 September 1974.

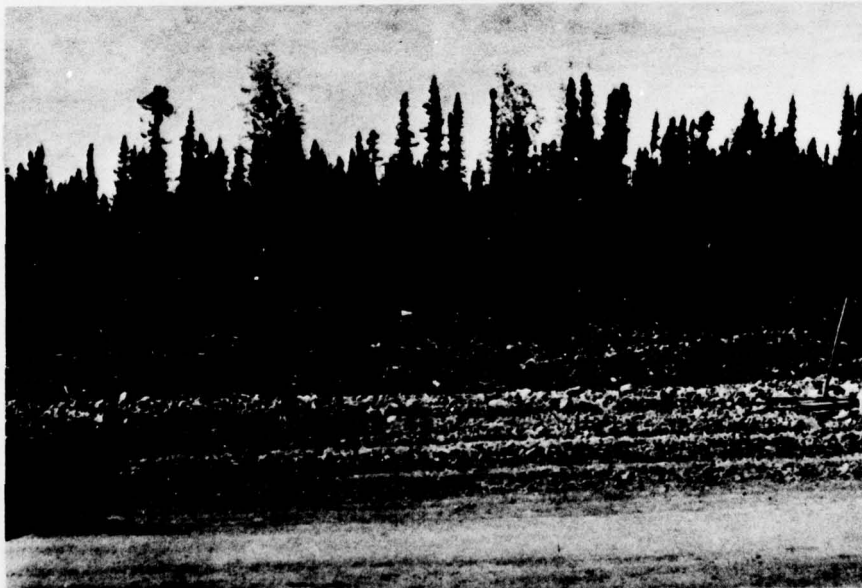
Figures 105 and 106 look left and right, respectively, at the cross section site on 27 June 1970. As seen in the photographs, trees were removed and the organic mat was stripped on each side of the road. The stripped material was replaced after constructing the embankment, and during the 1970 summer the areas were seeded.

105. Left embankment slope, Mile 16.3, 27 June 1970.

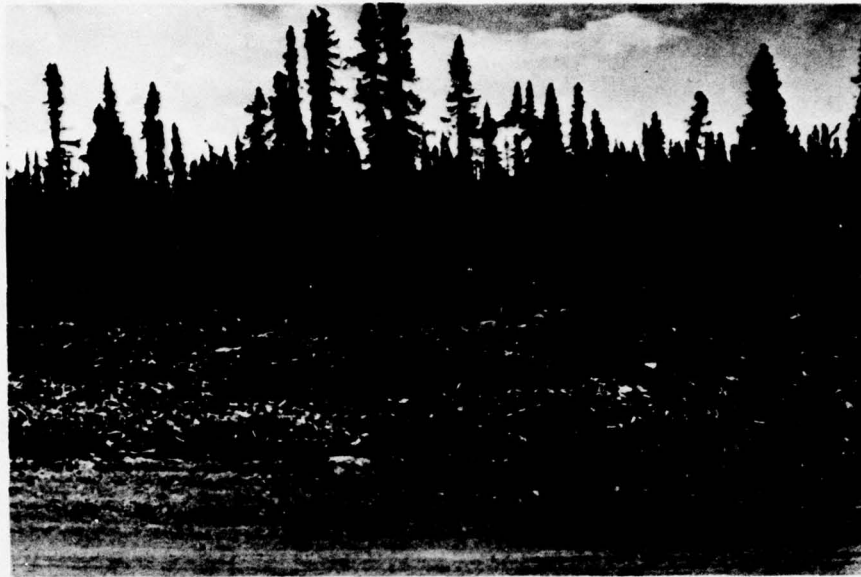
106. Right embankment of slope, Mile 16.3, 27 June 1970.
